DTRC - SSID - CR - 17 - 89

FABRICATION AND FEASIBILITY TESTING OF THE COMPOSITE ROADWHEEL FOR THE LVT-7 AMPHIBIAN VEHICLE

FABRICATION AND FEASIBILITY TESTING
OF THE COMPOSITE ROADWHEEL FOR THE
LVT-7 AMPHIBIAN VEHICLE

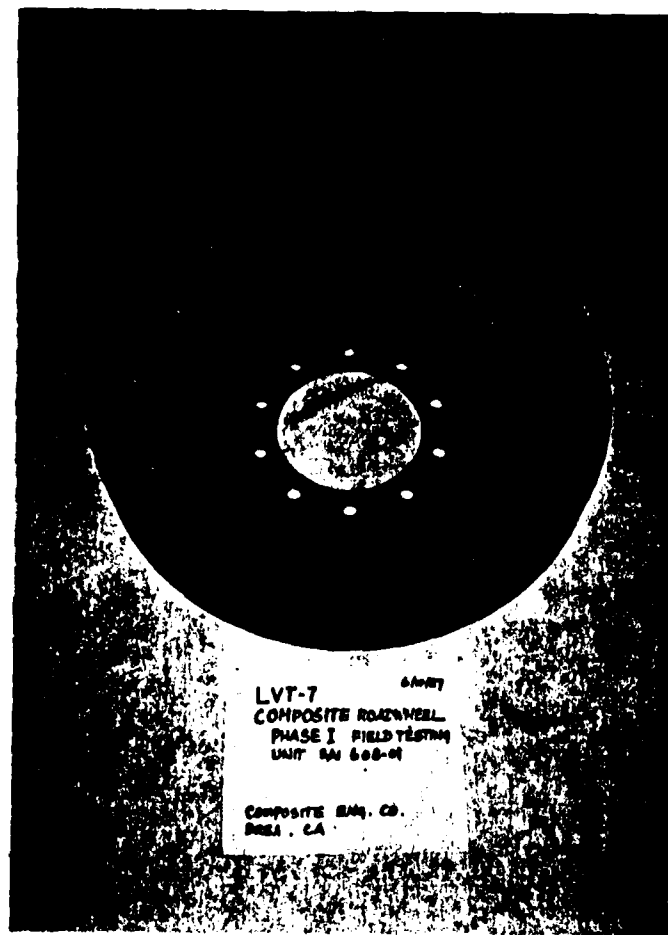
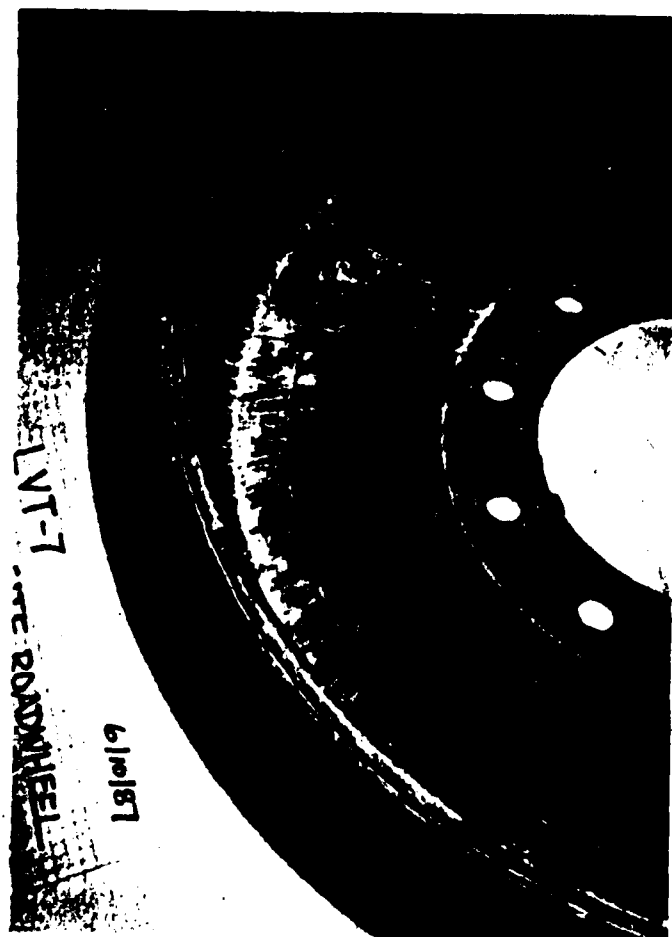
1. S/N 608-01 - Figures 37 and 38

This composite roadwheel operated 25.6 hours and approximately 330 miles. The failure analysis indicated poor bonding resulted in the loss of the stiffening ring during vehicle operation. Since vehicle operations continued after stiffening ring bond failure, extensive delamination and damage occurred in the hub, rim and wear plate areas.

Figure 37. S/N 608-01 after Field Testing

Figure 38. S/N 608-01 after Field Testing -
Rim Delamination

A short term solution would be to add mechanical locking pins acting as a shear restraint for the two pieces, and use of film adhesive to bond the components together. This approach would add a slight amount of weight to the roadwheel, however, an increase in manufacturing cost would result due to the additional machining operations. Tooling modification would be minimal.

A long term solution for this problem would be a re-design of the winding mandrel to allow winding of the stiffening ring and composite insert as a one piece structure. This would require a new collapsible mandrel and a modification to the existing manufacturing process. Although tooling cost increased for design and fabrication of the new winding mandrel, the potential cost savings per unit may be close to 50 percent due to a decrease in the machining and fabrication effort.

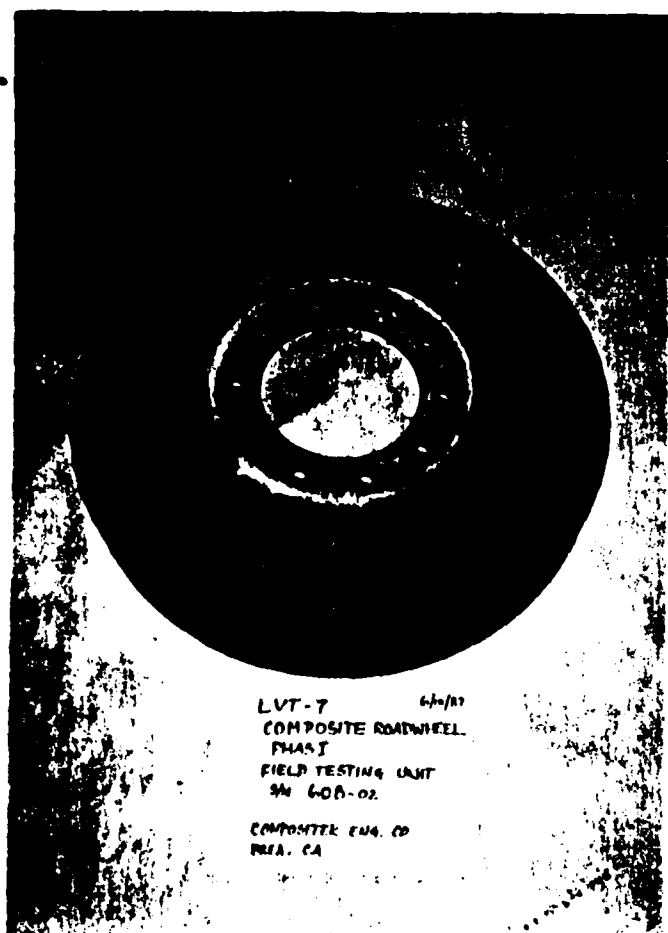
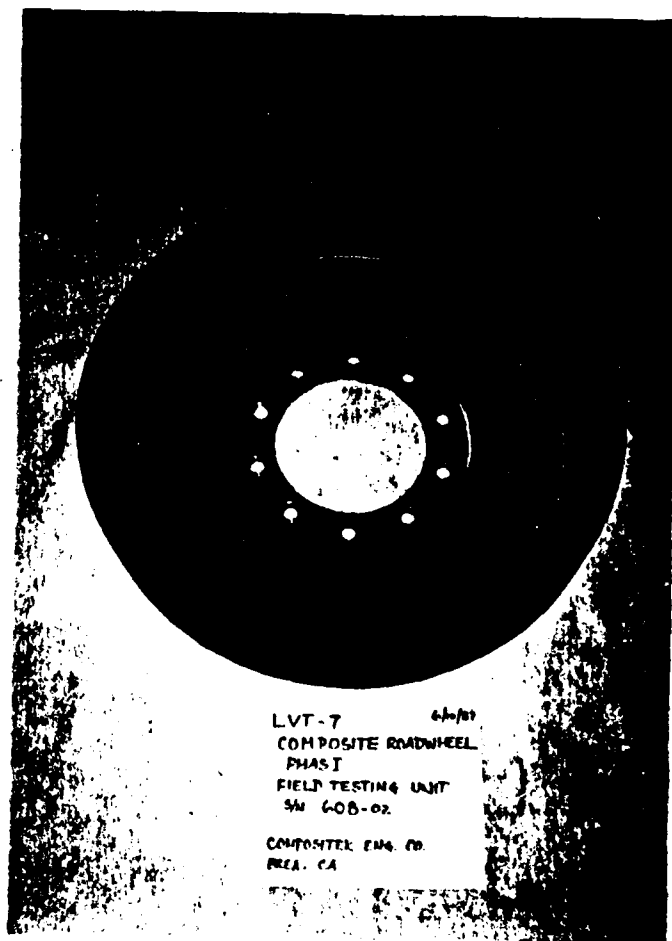
2. S/N 608-02 - Figures 39 and 40

This composite roadwheel did not show significant structural damage during the 25.6 hours of operation. However, partial debonding occurred between the urethane tire and the fiberglass insert. This wheel currently remains operable.

Figure 39. S/N 608-02 after
Field Testing -
outside view.

Figure 40. S/N 608-02 after
Field Testing -
inside view.

CEC recommends molding of the urethane tire and wear plate as a one piece structure such that forces imparted to the wear plate could be transferred into the urethane tire and reacted in shear. Otherwise, the solution would require the bonding of a metallic wear plate to the fiberglass insert.

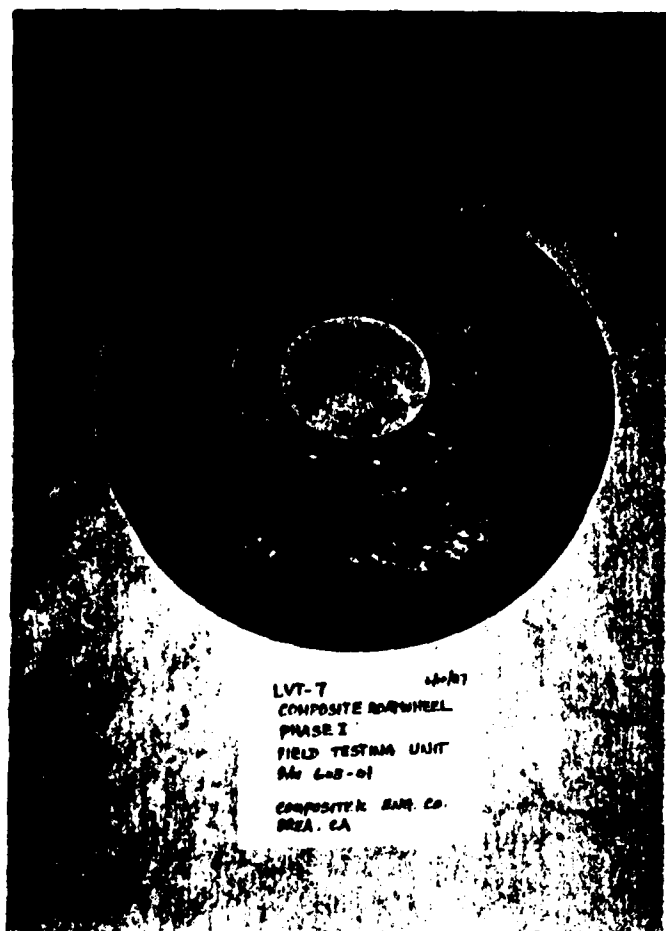
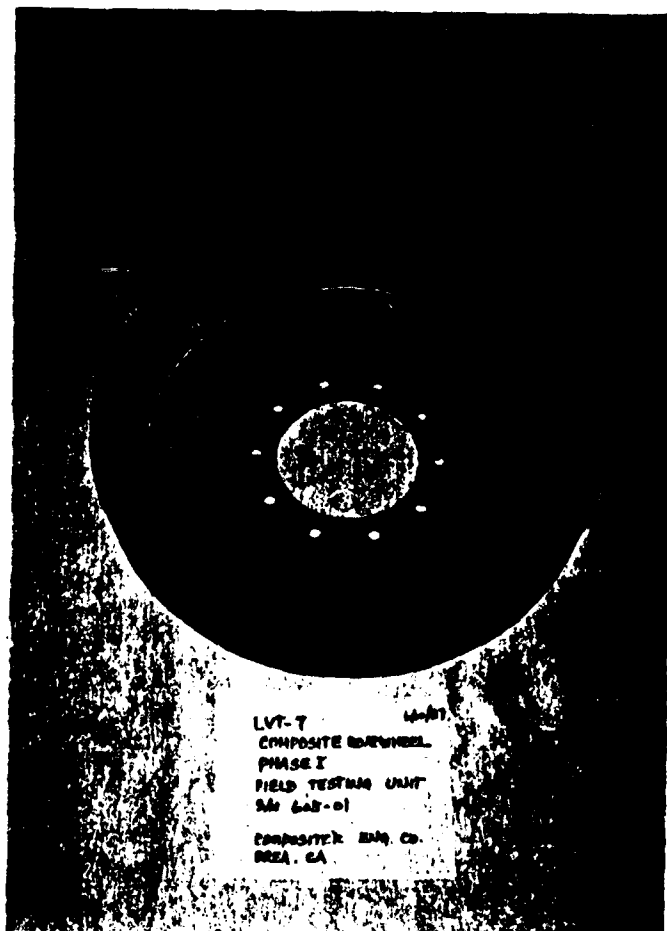
3. S/N 605-01 - Figures 41 and 42

The roadwheel failed after 7.9 hours of operation. The failure mode was a separation of the urethane wear plate, and a partial debonding of the stiffening ring. As for roadwheel S/N 608-01, continued operation after failure resulted in delamination of the fiberglass insert at the hub section.

The urethane wear plate which is molded separately from the urethane tire cannot resist the track horn impact forces. The urethane to fiberglass molded bond does not possess sufficient peel strength properties to overcome the peeling forces during operational contact. This problem was addressed during the design phase, however, due to the legal problems, the wear plate has to be molded separately.

Figure 41. S/N 605-01 after
Field Testing -
outside view,
lost wear plate.

Figure 42. S/N 605-01 after
Field Testing -
inside view.

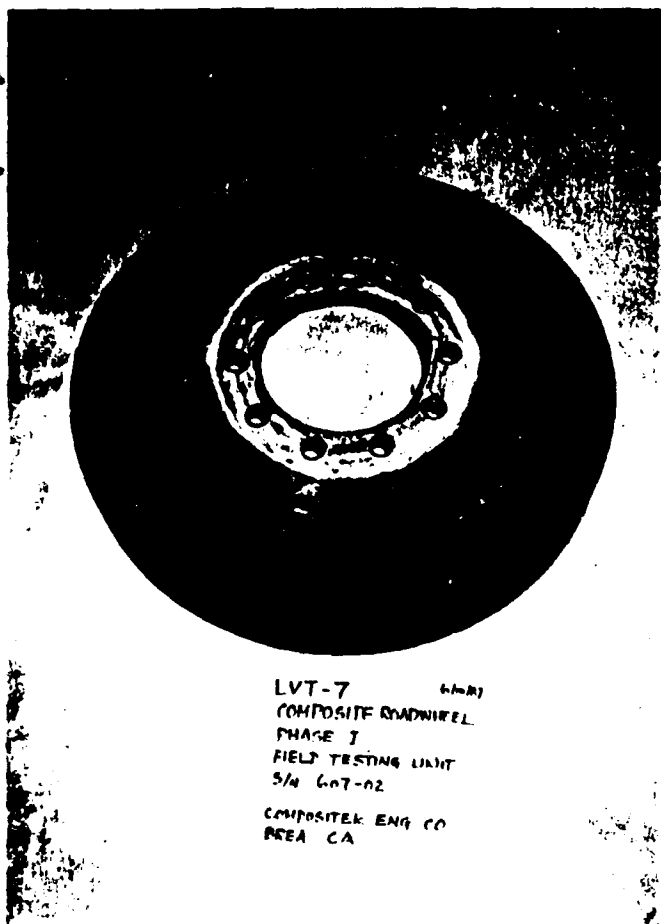
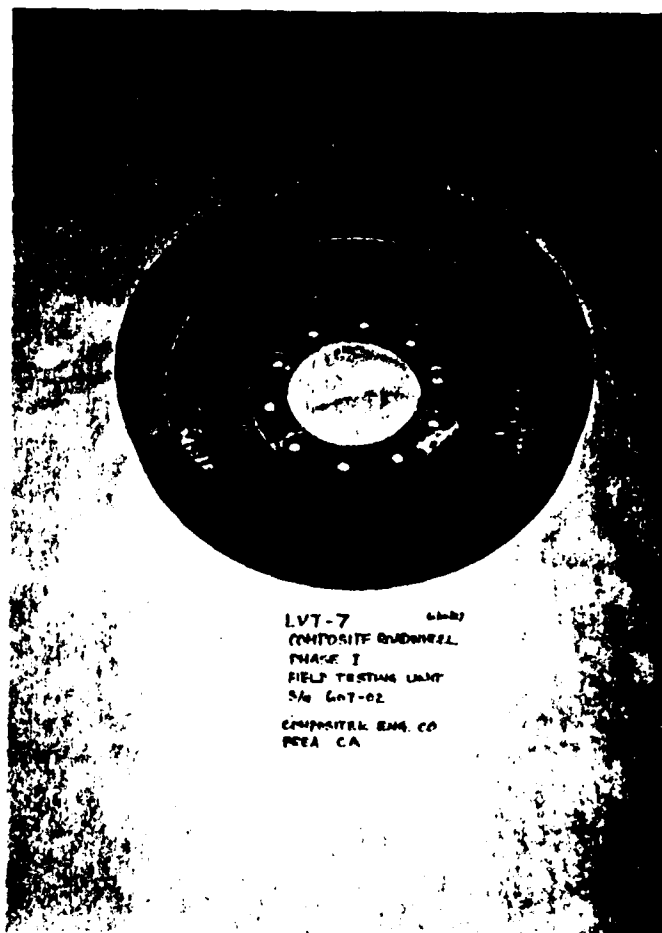
4. S/N 607-02 - Figures 43, 44 and 45

The failure mode of this wheel was similar to roadwheel S/N 608-01. The composite roadwheel lost the stiffening ring during operation and, subsequently, resulting in delamination at the hub area.

Figure 43. S/N 607-02 after Field Testing - outside view.

Figure 44. S/N 607-02 after Field Testing - inside view.

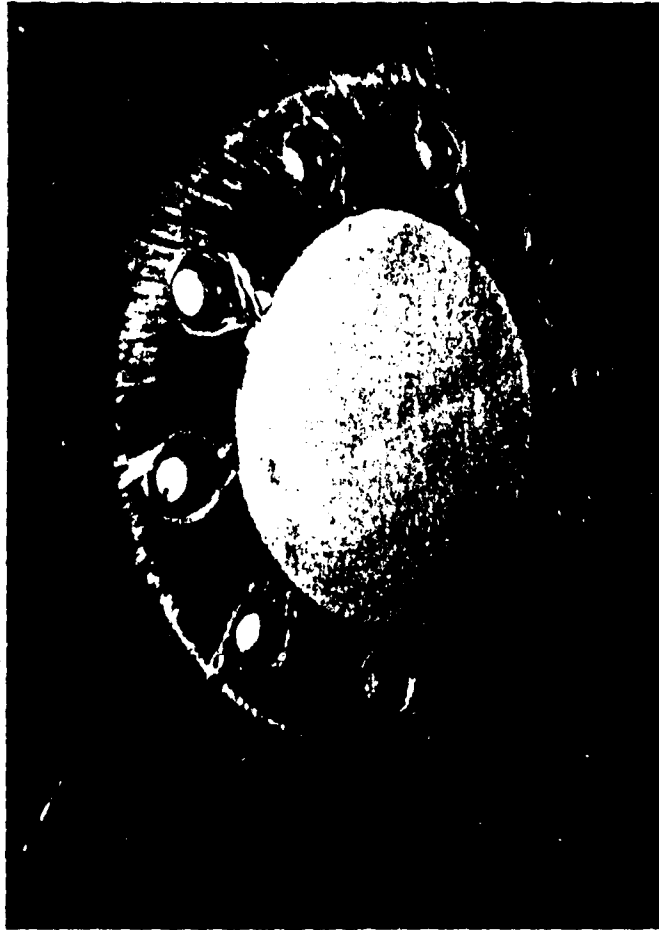
Cracking and delamination was observed around the machined outside surface of the hub area and the mounting holes. This delamination and cracking was caused by excessive roadwheel deflections after loss of the graphite stiffening ring. It has been learned from the Marine Corps Composite Sprocket Carrier Program that continuous fibers from the hub to the free edge of the rim could extend the fatigue life approximately 3 to 4 times. It is our recommendation to modify the hub section thickness configuration in order to allow for continuous fibers.

Figure 45. S/N 607-02 after Field Testing -
Delamination at Hub Section.
